DEPARTMENT OF TRANSPORTATION**DIVISION OF ENGINEERING SERVICES**

Contract #: 04-0120F4Cty: SF/ALA Rte: 80 PM: 13.2/13.9File #: 1.28**WELDING INSPECTION REPORT****Resident Engineer:**Pursell, Gary**Address:** 333 Burma Road**City:** Oakland, CA 94607**Report No:** WIR-012999**Date Inspected:** 14-Apr-2010**Project Name:** SAS Superstructure**OSM Arrival Time:** 630**Prime Contractor:** American Bridge/Fluor Enterprises, a JV**OSM Departure Time:** 1500**Contractor:** American Bridge/Fluor Enterprises, a JV**Location:** Job Site

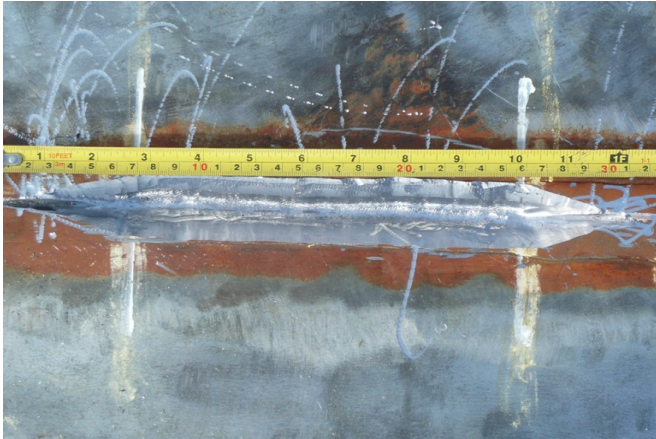
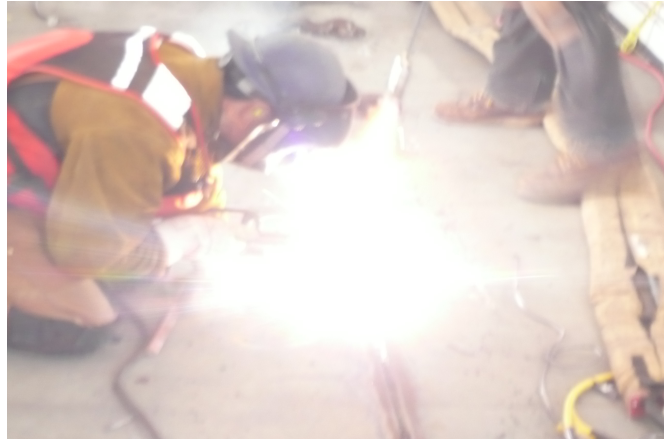
Upon the arrival of the QA Inspector at the above identified location, the QA Inspector randomly observed the ABF welders James Zhen and Chun Fai Tsui performing SMAW tack welding of the steel backing (pictured below). The QA Inspector noted the ABF welders were utilizing 5/32" E7018 low hydrogen electrodes with approximately 157 Amps for both welders. The QA Inspector noted the SMAW parameters appeared to be in general compliance with ABF-WPS-D1.5-F1200A. The QA Inspector performed random visual and dimensional testing of the fit up prior to and during the SMAW tack welding. The QA Inspector noted several areas of planar misalignment that exceeds that allowed by AWS D1.5-02 section 3.3.3. The QA Inspector noted the two members'

identified as 2W/3W-A were joined by welding on both sides of the steel backing bar. It was noted no additional fit up tasks would be performed after the members were joined by welding. The QA Inspector noted an incident report was previously written and submitted for approval for the above described issue.

After the SMAW tack welding was completed the QA Inspector randomly observed the ABF welders begin installing the weld tabs or weld run off tabs at the ends of the above described weld joint. The QA Inspector noted the ABF welders were preparing the weld joint for the submerged arc welding root/fill/cover pass to be performed on the Thursday 4/15/10.
